USAAMRDL TECHNICAL REPORT 73-62A
DESIGN GUIDE HANDBOOK FOR THE DESIGN OF
BALLISTIC-DAMAGE-TOLERANT SHORT-FIBER-MOLDED
AIRCRAFT FLIGHT CONTROL SYSTEM COMPONENTS

VOLUME I

DESIGN CRITERIA, CONCEPTS, TOOLING,
FABRICATION, TESTING, AND EVALUATION

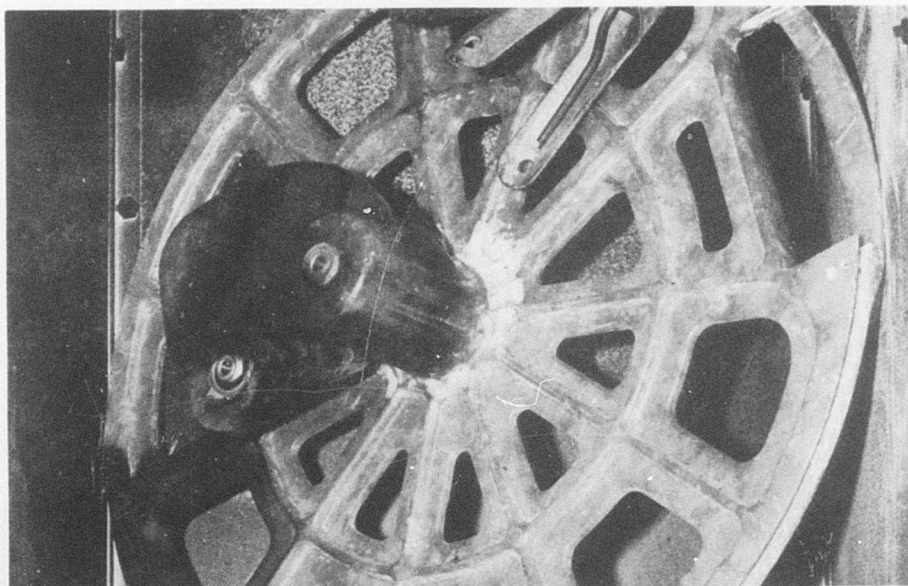
A. Burning After 315-Second Exposure to Flame

B. Fire Damage After Test

Figure 69. Burning and Extent of Fire Damage in the Crank Area of the Quadrant Assembly.
